TEST REPORT

**INSTALLATION AND ENVIRONMENTAL TEST
OF LIGHT SIGNAL MONITOR FACILITY AN/TSQ-()**

DSL R-146

1 June 1966

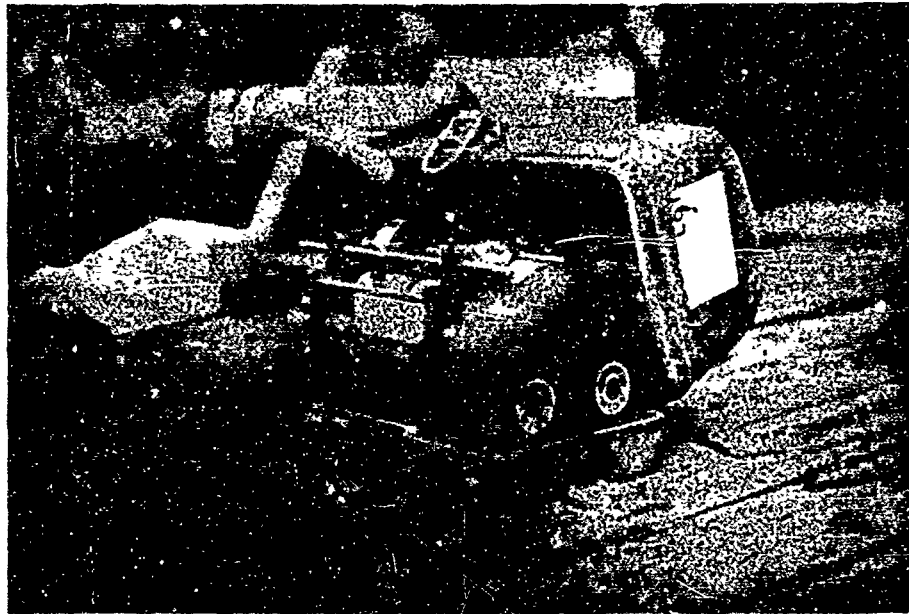
FIGURE 11. IMPACT METER MOUNTED ON FLAT CAR

Since railroad personnel had installed an impact meter on the car with the shelter (Figure 11), it was hoped that a quantitative impact record could be included in this report. However, during the early part of the impact testing, the meter indicating mechanism was driven against the stops and the meter ceased to operate.

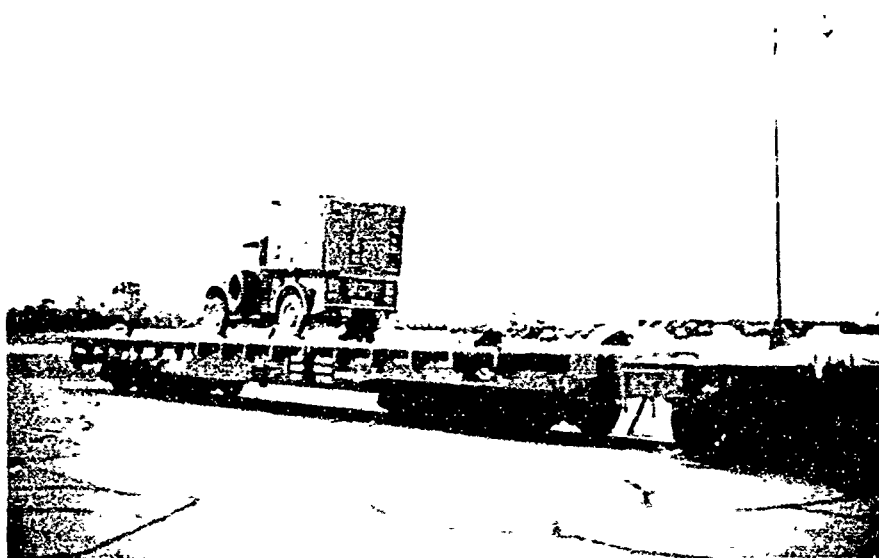
FIGURE 12. RAIL TRANSPORT TEST

The first three impacts were performed with the system being driven backward into the stationary mass (Figure 12). The system was then reversed for the last two impacts (Figure 13). The following table indicates the results of the impact testing:

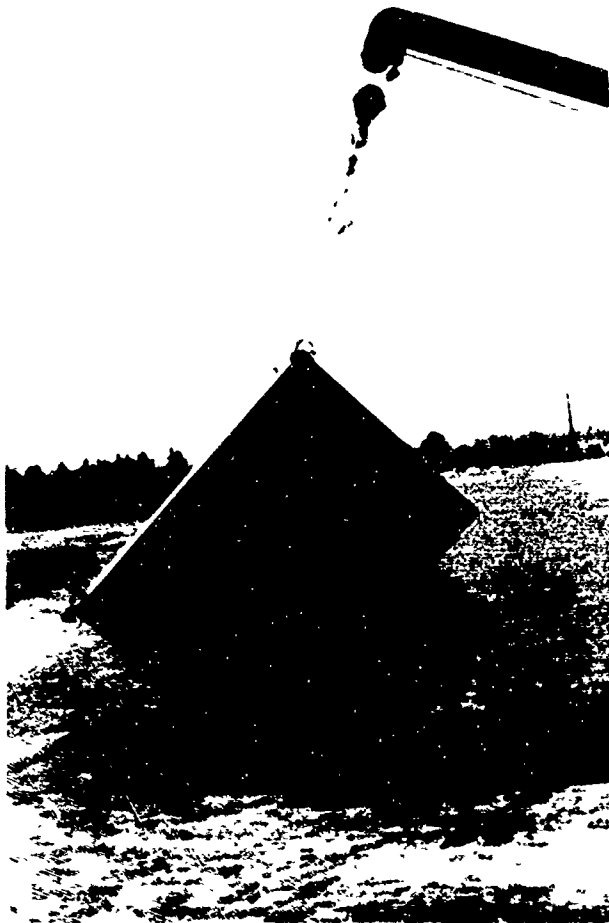
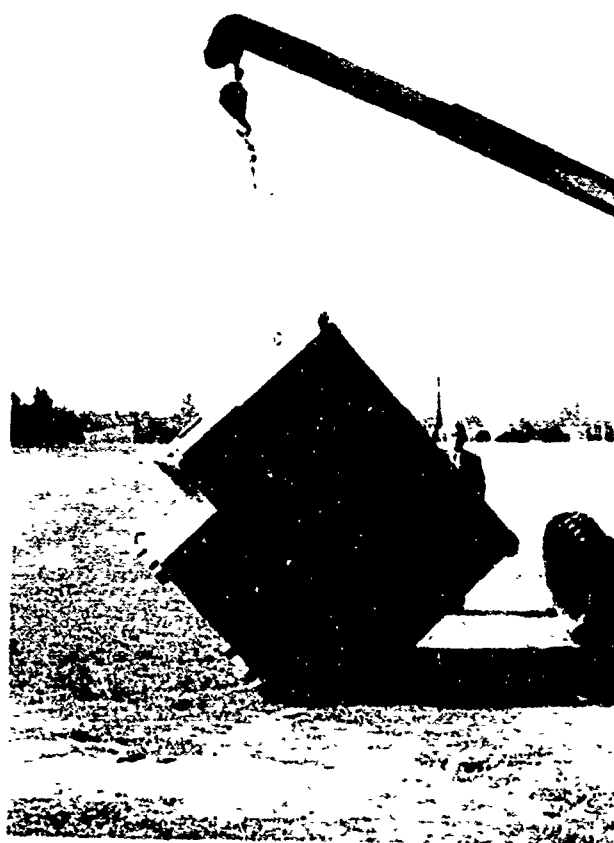
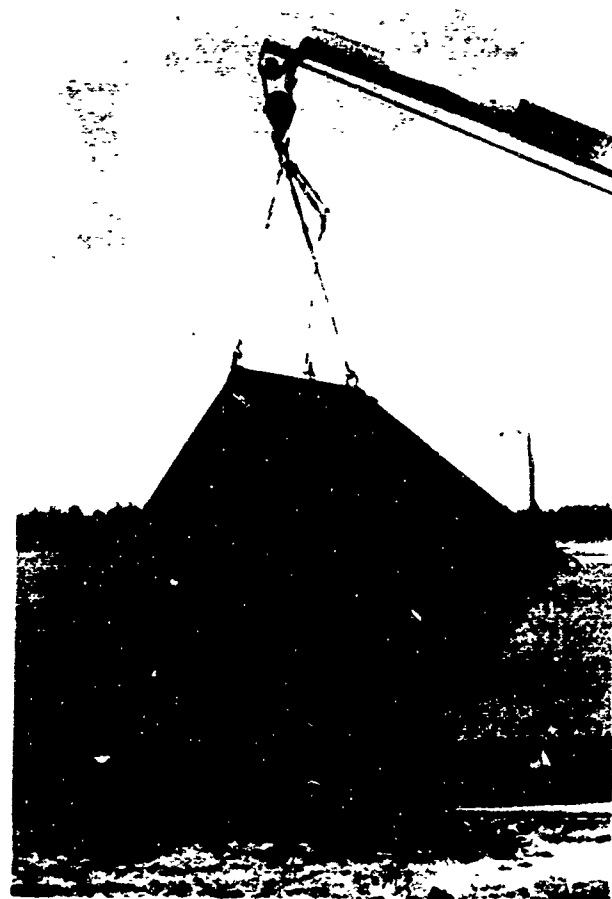
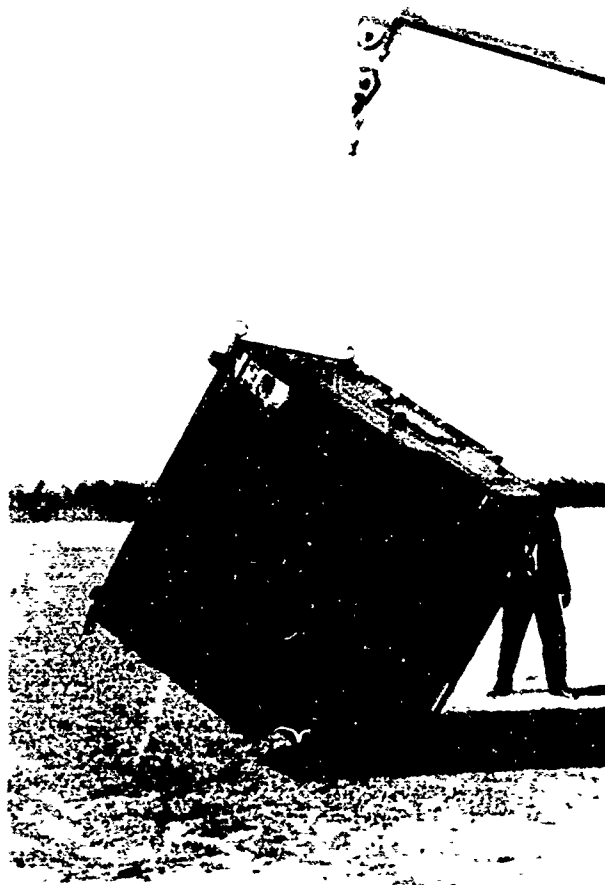
4. Tilt Test - The system, with all components installed for transit, was lifted by each pair of corners and tilted through its equilibrium point. The relatively high center of gravity of the system due to the shape of the shelter caused the critical tilt angle to be reached before the system became fully suspended from the surface. When the critical tilt angle was then exceeded, the shelter started to tip over, being stopped only by the suspending cables snapping taut. In this way, the system was not only tilted further than it would be when fully suspended but it was also subjected to a whipping action as it tried to tip over. Figures 19 through 22 show the system being lifted by each pair of corners. There was no damage to the system or its components as a result of the tilt test.

FIGURE 19. TILT TEST

FIGURE 20. TILT TEST

FIGURE 21. TILT TEST

FIGURE 22. TILT TEST

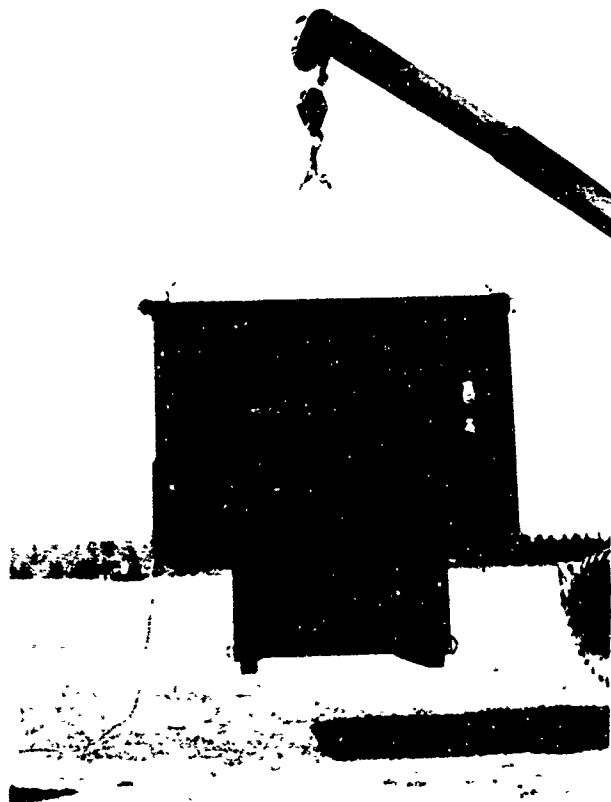
FIGURE 23. DROP TEST - PRIOR TO DROP

5. Drop Test - The system, with all components installed for transit was suspended by four corners at a height of 1 1/2 feet (rather than the specified one foot height) and dropped once on a hard earth surface. The shelter sling was connected to the crane's hook with a rope-actuated snap link. When the control rope was pulled, the shelter sling became completely disengaged from the crane cable, allowing the system to free-fall to the ground.

Figure 23 shows the suspended system just prior to being dropped. Since the system was not perfectly balanced, it tended to tilt forward slightly as it fell. Figures 24 and 25 show the resultant minor crumpling of the shelter and skids. Figure 26 and 27 show the shelter damage beneath each equipment rack shock mount.
